Effects of high-pressure cooling in the flank and rake faces of WC tool on the tool wear mechanism and process conditions in turning of alloy 718

Tamil Alagan, N., Hoier, P., Zeman, P. et al (2019). Effects of high-pressure cooling in the flank and rake faces of WC tool on the tool wear mechanism and process conditions in turning of alloy 718. *Wear*, 434-435. <http://dx.doi.org/10.1016/j.wear.2019.05.037>

Nageswaran Tamil Alagan^{a,*}, Philipp Hoier^b, Pavel Zeman^c, Uta Klement^b, Tomas Beno^a, Anders Wretland^d

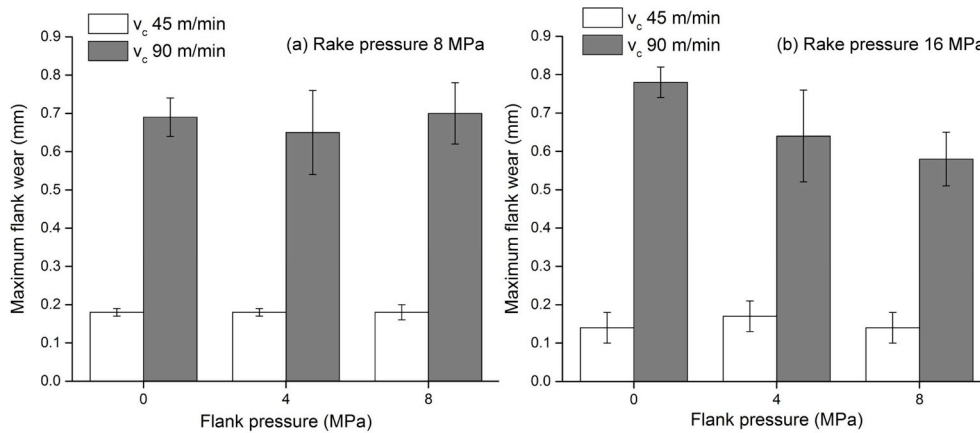
Fig. 4. Comparison of measured maximum flank wear for different cutting speeds and flank pressures; (a) Rake pressure 8 MPa (b) Rake pressure 16 MPa.

The maximum flank wear was measured for all the cutting trials (including the replicates, which is shown by the error bar), see Fig. 4. In addition, the flank wear area of the worn zone was measured and values are plotted as shown in Fig. 5. While comparing the effects of varying v_c , the difference in mean value of VB_{\max} and VB_{area} can be readily seen. The numbers have increased significantly (by approx. 3 to 4 times) for all the cutting conditions. Despite using a high-pressure coolant, the increase in cutting speed reduced the tool life significantly. This is in line with the theory that increased cutting speed leads to rises in the temperature at the cutting edge due to the heat generated in tool-chip and tool-workpiece shear zones, which consequently accelerates tool wear and lowers tool life [6,14].

For v_c 45 m/min, an increase in rake pressure from 8 to 16 MPa for constant flank pressure of 8 MPa led to a reduction of the mean values for VB_{\max} and VB_{area} by approx. 20 and 17%, respectively. The corresponding wear levels were not significantly influenced by similar cutting conditions by flank pressures of 0 and 4 MPa. For a v_c of 90 m/min and a rake pressure of 8 MPa, an increased flank pressure did not lead to a reduction of the maximum flank wear and flank wear area (Fig. 4 (a) Fig. 5 (b)). However, if the rake pressure is increased to 16 MPa (Figs. 4 (b) and Fig. 5 (b)) the mean VB_{\max} and VB_{area} are reduced by approx. of 25 and 20%. The wear levels were not influenced when no flank coolant was used and when the flank pressure was 4 MPa. Finally, at a flank pressure of 8 MPa, the downward wear rate trend was regained.

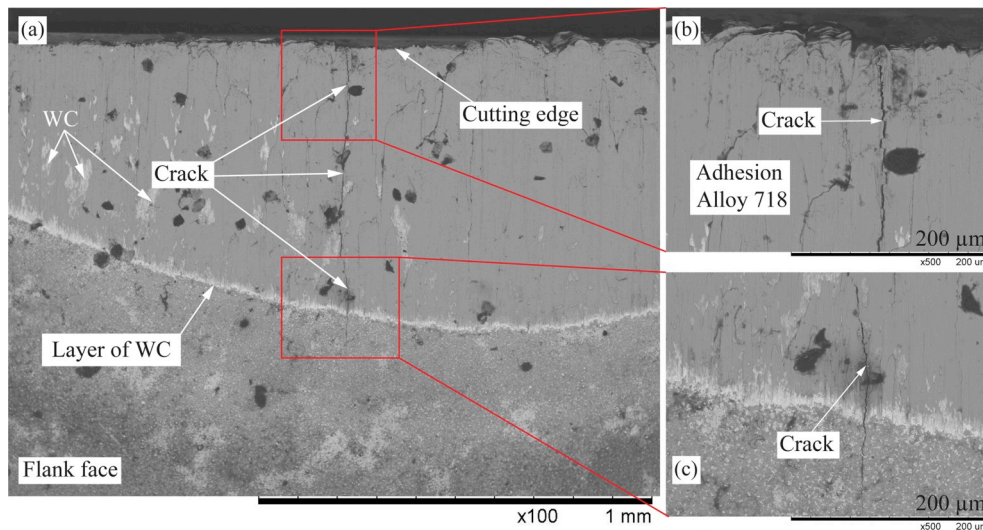
Fig. 8. Flank face of the cutting tool at rake pressure of 16 MPa and flank pressure of 8 MPa (a) Flank wear focussed on the crack (b) crack from the cutting edge, and (c) propagation of crack across the flank wear area.

increased significantly. Apart from BUL, BUM and flank wear, the dominant wear found was the growth of crack in both rake and flank face, disregarding the high-pressure cooling in the rake and flank face almost all the tools showed cracks. These cracks can be seen in the premature stage of the tool breakage. The tools were intensively damaged compared to the lower cutting speed. As shown in Fig. 8, for the rake pressure of 16 MPa and flank pressure of 8 MPa, the crack propagates from the cutting edge across the flank wear zone as can be seen in Fig. 8 (b and c). A grey area can be seen on the flank wear land, which was found to be adhered Alloy 718 material.

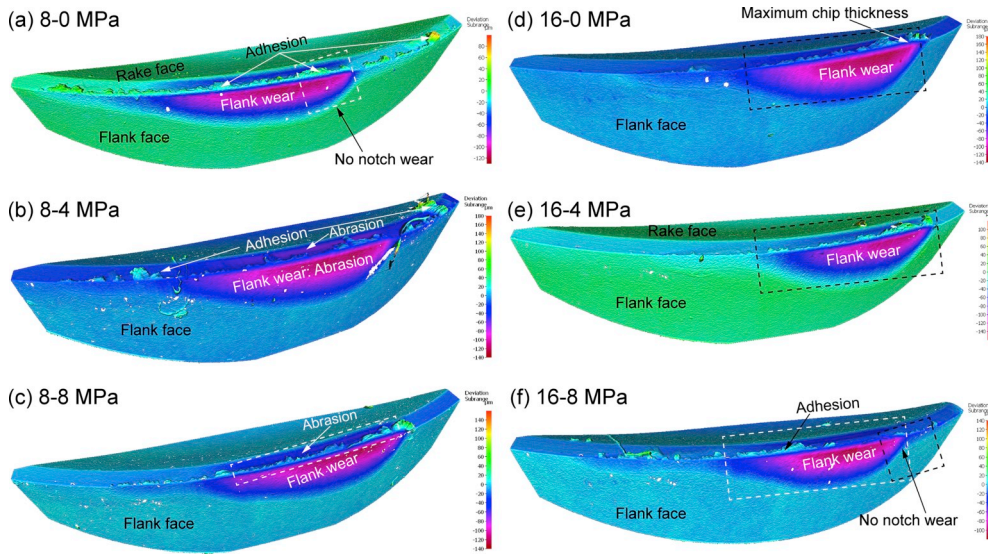
Fig. 12. Volume difference measurement of the cutting tools at different pressure conditions for v_c 90 m/min.

Various researchers like Ezugwu et al. [20, 21], Machado and Wallbank [22], and Suárez et al. [23] have investigated machining with the use of high-pressure coolant and reported increases in tool life by lowering flank wear compared to flood cooling or even dry cutting conditions. However, the dominant depth of cut notch wear was observed in their research work for both carbide and ceramic tools. This failure mode was reported to be the most prominent cause for tool failure while machining Alloy 718. Shalaby and Veldhuis [24] mentioned that the probable cause of notch wear can be caused by one effect or a combination of the following: adhesion effects, work-hardened surfaces, stresses, adverse chip flow conditions with chip curling, and temperature gradients. Further, notch wear is the dominant tool failure criterion when machining at higher cutting speeds. However, in some cases notch wear was identified even at lower cutting speeds [23]. In this experiment, no such observation of groove shape or notch wear were found for any of the cutting tools at the depth of cut line (at approx. 3.6 mm as shown in Figs. 3 and 12).

At higher cutting speed of 90 m/min and disregarding the strength of insert geometry and flank pressure conditions, the tool wear mechanism changed between 8 and 16 MPa. Instead of crater wear, which is one of the common wear mechanism in machining Alloy 718, loss of material was observed on the cutting edge (see Fig. 12 a, b and c), in form of abrasion. However, the shape looks like a “crater valley” than a localized crater wear. For the cutting tools machined with a rake pressure of 16 MPa, abrasion rate and flank wear area were less. In addition, the tool-chip contact area was more constrained and showed less abrasion compared to the tools with a rake pressure of 8 MPa (see Fig. 12).

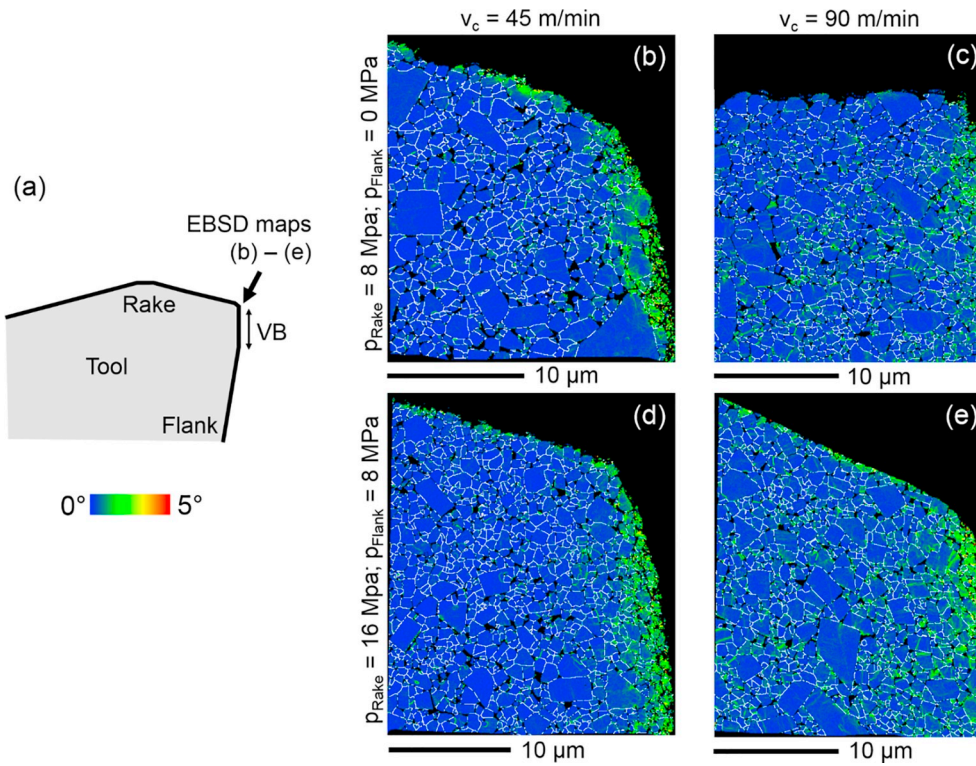
Fig. 13. EBSD results of worn cutting tools: (a) schematic representation of cross section through worn tools with location of EBSD maps indicated; (b)–(e) EBSD local misorientation maps of WC grains for low cutting speed (left column) and high cutting speed (right column) with low and high coolant supply pressures to rake (p_{Rake}) and flank (p_{Flank}) in the upper and lower row respectively. The local misorientation maps were generated using 3×3 pixel filter size, 5° subgrain exclusion angle. Grain boundaries ($> 10^\circ$) are shown in white.

dependence of the machining and coolant conditions, cross sections of four worn inserts were prepared and examined with EBSD regarding the plastic deformation of WC grains. Local misorientation maps of EBSD datasets acquired at the cutting edge can be seen in Fig. 13. The colour of every pixel represents its average orientation difference with a set of surrounding pixels [13]. According to the colour code in Fig. 13 (a), undeformed regions with low/no local misorientation are therefore shown in blue while higher misorientations due to deformation of the WC grains are shown by green, yellow, and red. As can be seen, the majority of all four maps are coloured blue indicating that these areas are free of deformation. However, close to the worn surfaces on the rake and flank faces, green and yellow coloured pixels show significant local misorientation (deformation) within WC grains. The affected zones extend a few rows of WC grains into the tools (below 5 μm). The examined part of the rake face in Fig. 13 (c) shows an exception where no local misorientations can be seen in close vicinity to the worn tool surface. As indicated by the significantly different geometry of the cutting edge (compare with e.g. Fig. 13 a), it is believed that this tool exhibited local chipping of the cutting edge in the region where the tool was sectioned. Brittle fracture of the tool material due to chipping instead of gradual wear might explain the absence of deformation in Fig. 13 (c).

the tools used with the higher cutting speed of 90 m/min as compared with the tools used for 45 m/min cutting speed (compare Fig. 13 (c and e) with Fig. 13 (b and d)). This is likely to be the result of higher thermal and mechanical loads, which are expected to act on the cutting edge when for the higher cutting speed, resulting in a larger zone of the network of WC grains to be deformed during cutting.
